BEFORE THE PUBLIC SERVICE COMMISSION

KENTUCKY UTILITIES COMPANY) CASE NO. 91-26	9
ALLEGED FAILURE TO COMPLY WITH) }	
COMMISSION REGULATION 807 KAR 5:006, SECTION 24

ORDER TO SHOW CAUSE

ELECTRIC UTILITY ACCIDENT INVESTIGATION

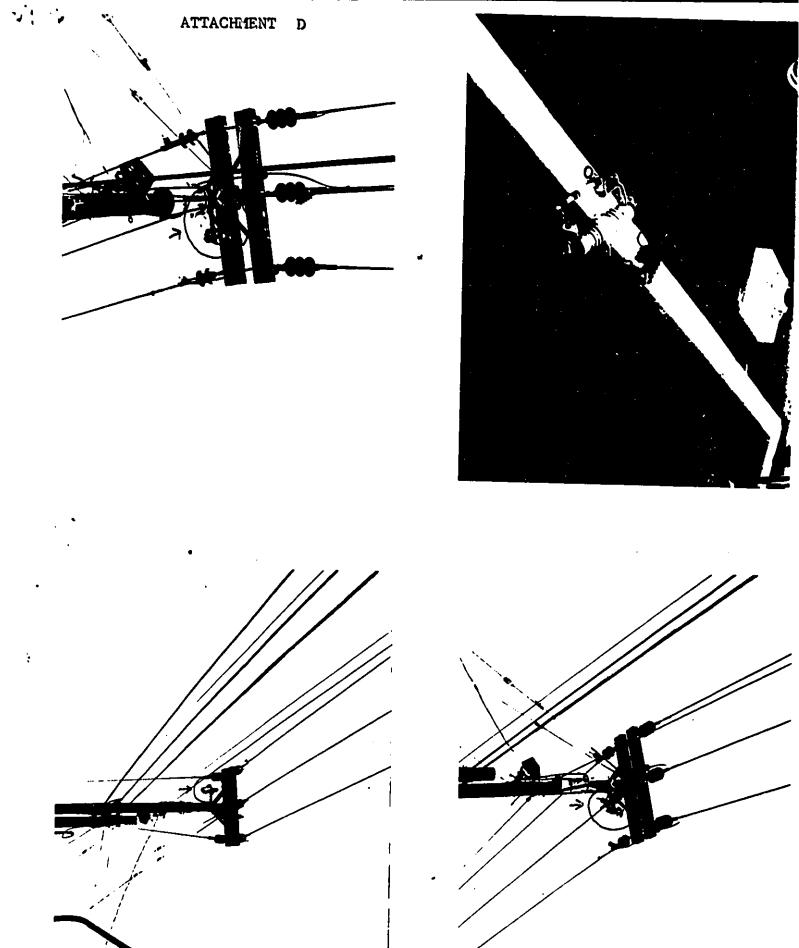
Calculation Sheet

Temporary Cutout (inc. SA fuzz) Transformer	Utility		Checked by		
(Jumper)		Primary	Lightning Arrector		
Transformer		3ypa			
		· · · · · · · · · · · · · · · · · · ·	Transformer		
	,

In order to replace the cutout, a temporary By Pars line between the Lightning Herosfer and the Transformer are established.

Accident occurred when into ut was partially removed from highwing arrestor node and ground lie inadvertually connected with Arrestor causing phase to grown short with resulting flash.
